The Locomotive

THE HARTFORD STEAM BOILER
INSPECTION AND INSURANCE CO.

VOL. XXXII.

HARTFORD, CONN.,
1918-1919.

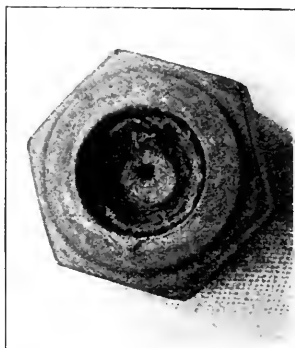
FIG. 1.

in his boiler by a false water registration in the gage glass. When the glass was removed from its fittings it was found that its lower or water end had at some past date caused inconvenience by leaking, and to stop this leakage a piece of rubber packing, circular in shape, had been inserted in the stuffing box, which had practically closed up the opening so that water could not rise in the glass to show the level in the boiler. That the attendant saw water in the glass before and after the accident we have not the slightest doubt, and the presence of the water can be accounted as due to the accumulation of condensation coming from the upper or steam connection. Fig. 1 shows the packing nut used on the lower fitting for compressing the packing around the glass so that it will be water tight, and you will note that the orifice is completely filled up with rubber, except for a small hole (less than $1/16$ inch in diameter), in the middle. It is also to be noted that at the time of the accident, sediment which had settled in the bottom of the glass had closed off the opening to a still greater extent.

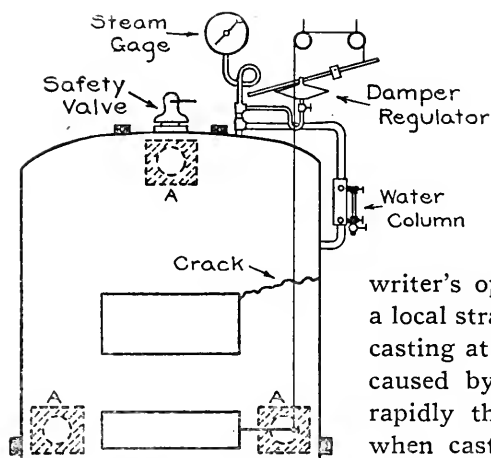
FIG. 3. SHADED PORTIONS, A, INDICATE PADS.

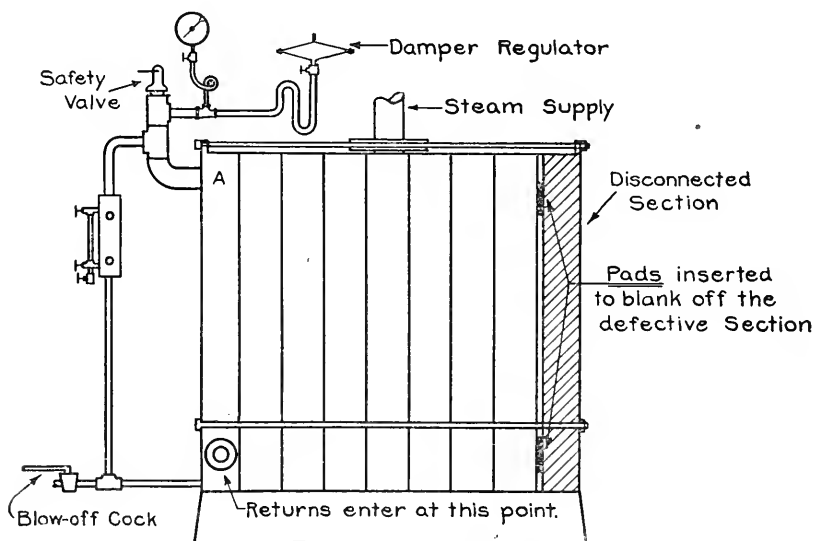
FIG. 4. SHOWING RELOCATED FITTINGS. PLUG AT A TO BE REPLACED WHEN FITTINGS ARE ATTACHED TO NEW FRONT SECTION.

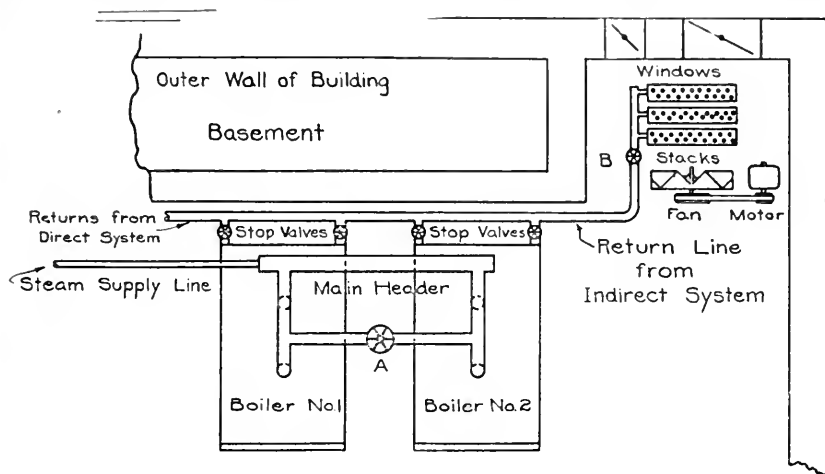
FIG. 5.

public school. On examining No. 2 boiler, it was plainly seen that the cracking of three of the sections was due to low water.

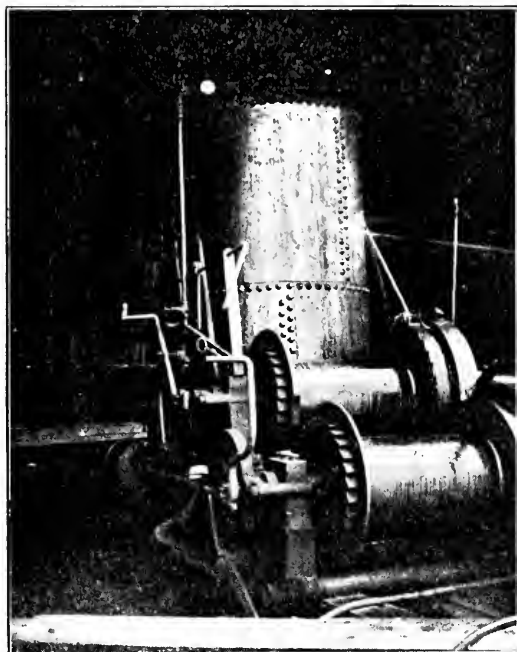
FIG. 1. WATER POURING FROM THE LAP CRACKED BOILER WHEN UNDER TEST.

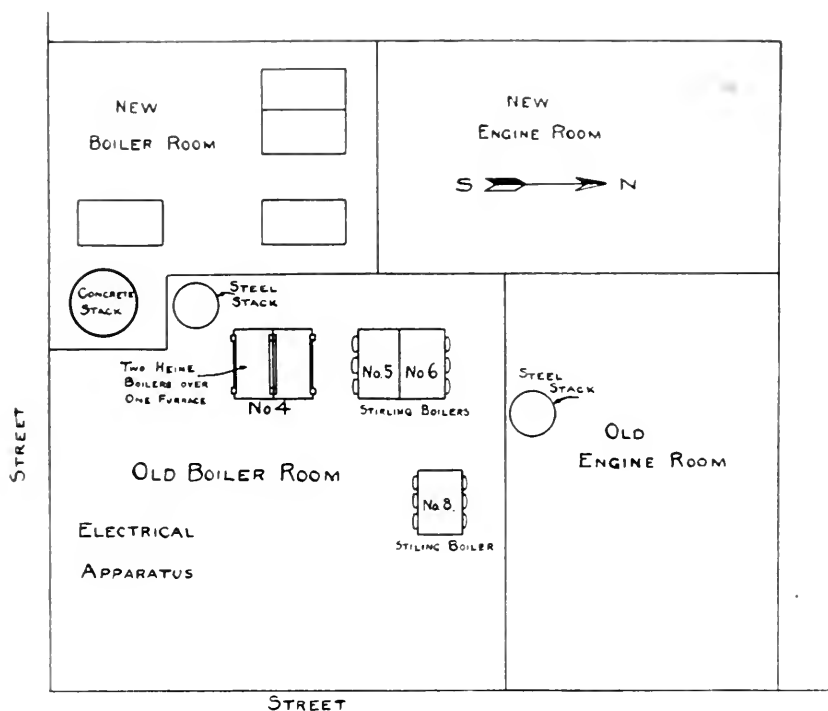
About 8.20 P. M. on Friday, February 21st, a very violent boiler explosion occurred at the plant of the Mobile Electric Co., Mobile, Ala. Two boilers of different makes were concerned with the explosion; both boilers were of the water-tube type—one being a Heine and one a Stirling. Four persons were killed by the explosion, three outright at the time of the accident, and a fourth injured, whose death subsequently resulted. The explosion was followed by a fire which caused still further damage to the wrecked plant.

EXTENT OF THE DAMAGE.

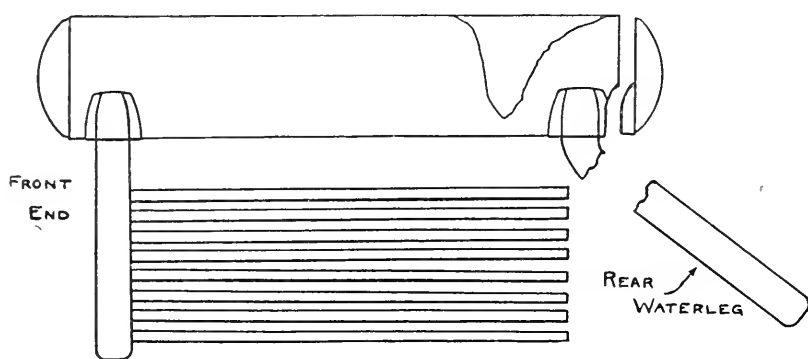
CONDITION OF THE EXPLODED BOILERS.

The Heine boiler, as far as the appearance of the parts shown after the explosion, seemed to be in good condition. The closed head on the mud drum of the Stirling boiler numbered 6, which was on the south side of this boiler next to number 5, was very seriously corroded; in fact, the lower half of the head on this boiler was reduced to approximately $\frac{3}{16}$ inch in thickness. It appears that on this account the Government experts and others who examined the ruins decided that the Stirling boiler was the initial cause of the accident, and that the Heine boiler had exploded due to shock produced by the explosion of the Stirling. Notwithstanding this there are several reasons which seem to show that the

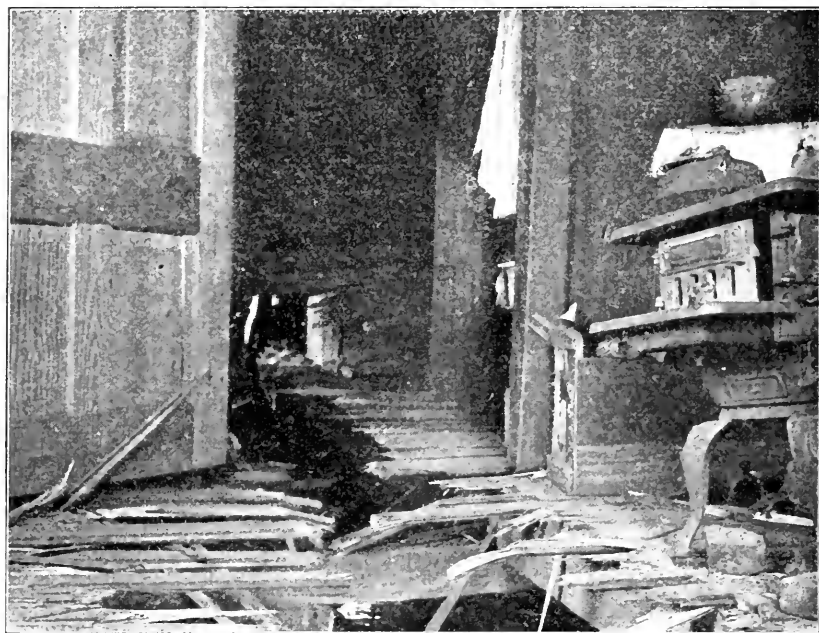
FIG. 2. THE DAMAGED DWELLING.

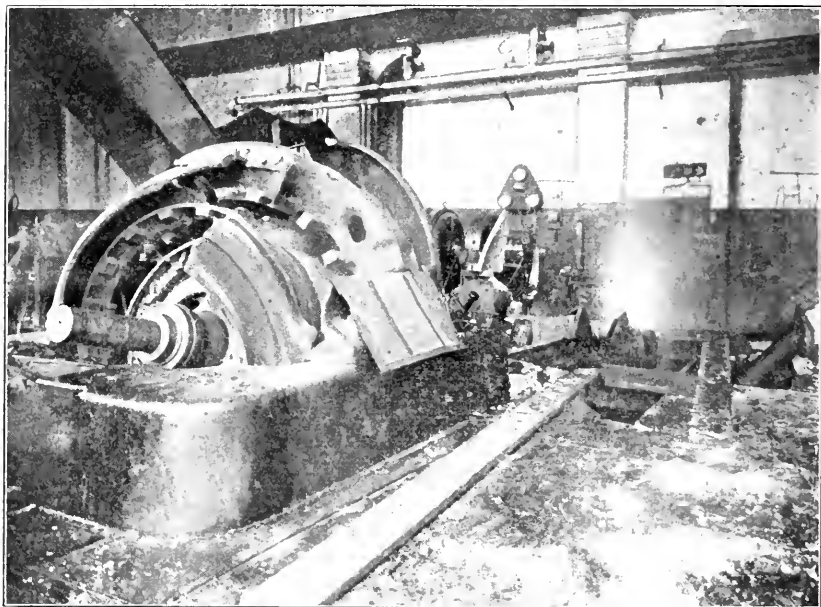
FIG. 1. VIEW OF GENERATOR

Explosion of a Large Steam Turbine.

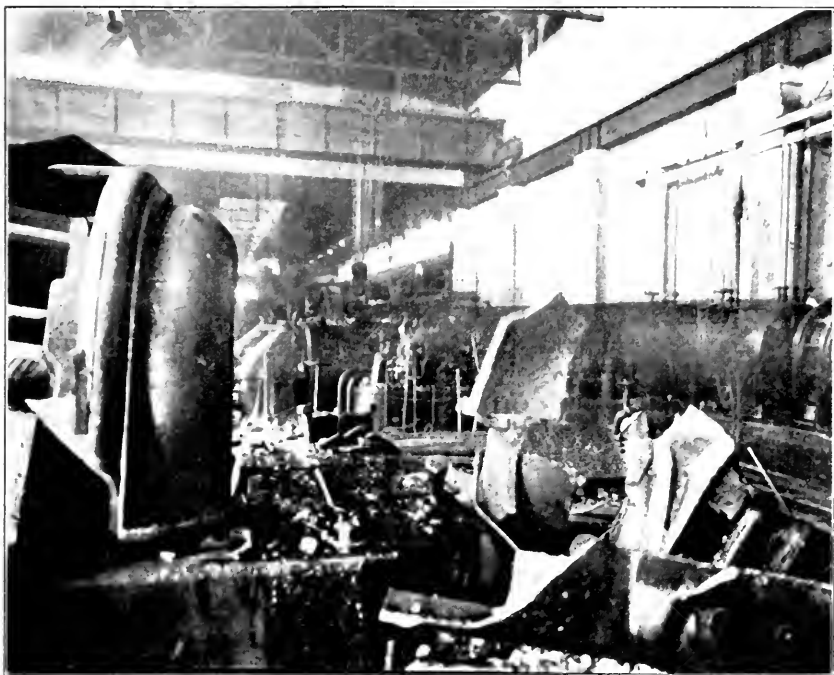
lights was caused by the loss of excitation on two and perhaps all of the four generating units and that thus these units were suddenly relieved of load. Two of the turbines, after the accident, were found with their automatic speed limits tripped and the steam shut off. It would appear from the report also that the investigator was satisfied that there was no material increase in speed of the wrecked turbine in the interval between the dimming of the lights and its destruction. The evidence to substantiate this negative conclusion was not given in the published report. It, however, must have been convincing to the

FIG. 2. TURBINE END OF WRECKED MACHINE

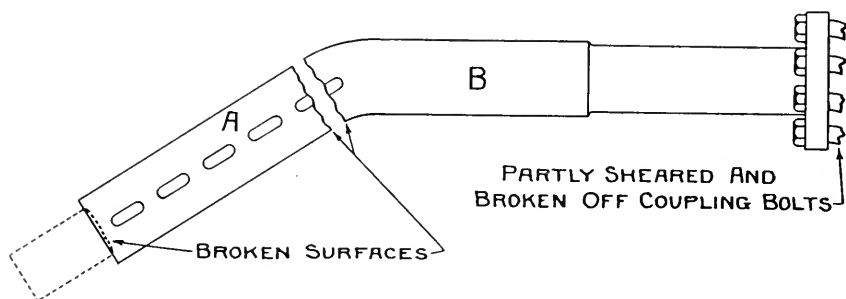
The wreck of the turbine itself was so complete and its remains consist in the main of such small fragments that from them it was impossible to determine at the examination made by a representative of our company what part failed first. The frame of the generator and its bearing pedestals were broken up and even the bed plate was

FIG. 3. SKETCH OF BROKEN TURBINE SHAFT

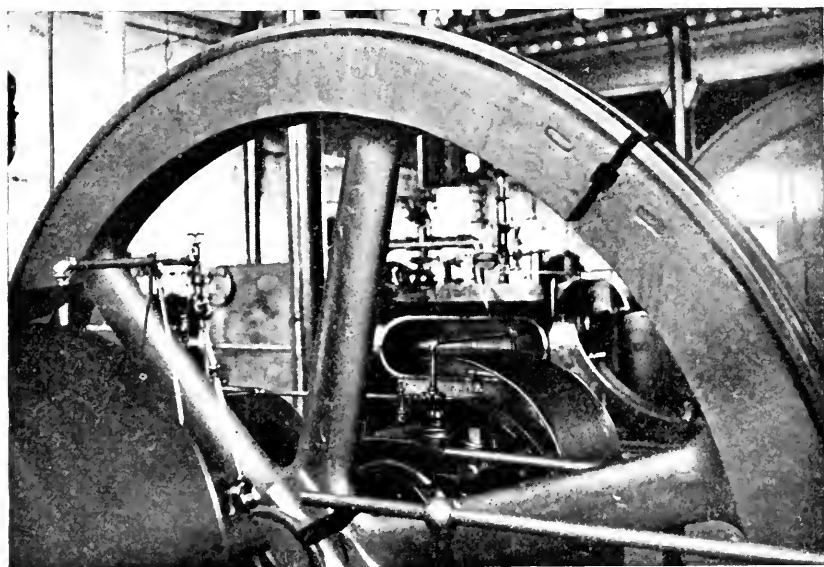
FIG. 1

An Unusual Flywheel Accident.

beyond some major fractures of the hub and arms of the wheel. The only usable picture we were able to secure of the wrecked flywheel does not clearly show that it was a complete loss. Such, however, was the case. The wheel in question was nine feet in diameter and was used in connection with a refrigerating engine. By the lucky coincidence that someone happened to be near the trottle and closed it at the moment the engine started to race, a complete disruption of the wheel was prevented. The wheel rim must have attained a considerable velocity as the links forming the rim-joints had stretched fully an inch due to the centrifugal force tending to separate the two halves of the wheel.

These links, which are round and of steel, are inside of the rim, a suitable recess being left in the rim to receive them, and they are secured to the rim sections by means of cotter keys. The only visible parts of the rim joint, therefore, after the wheel is assembled, are the ends of the cotter keys. They can be distinctly seen in the illustration, as can also the separation of the rim at the joint due to the stretch of the links.

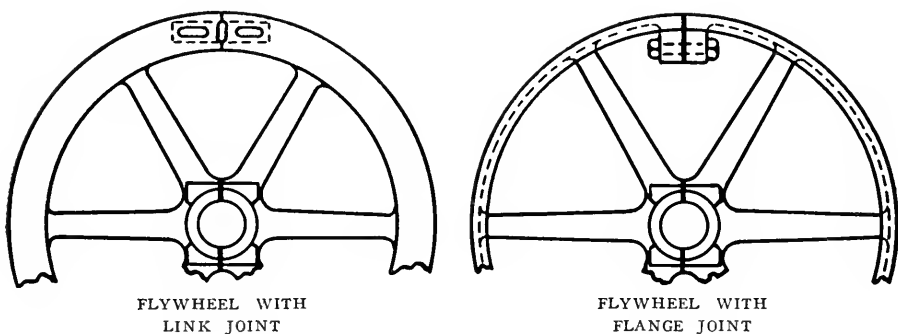
FIG. 2

When the links commenced to stretch, such a severe strain was transmitted through the arms to the hub-bolts that two of them broke off and one section of the hub itself split in two, while one arm was completely broken free from the rest of the wheel.

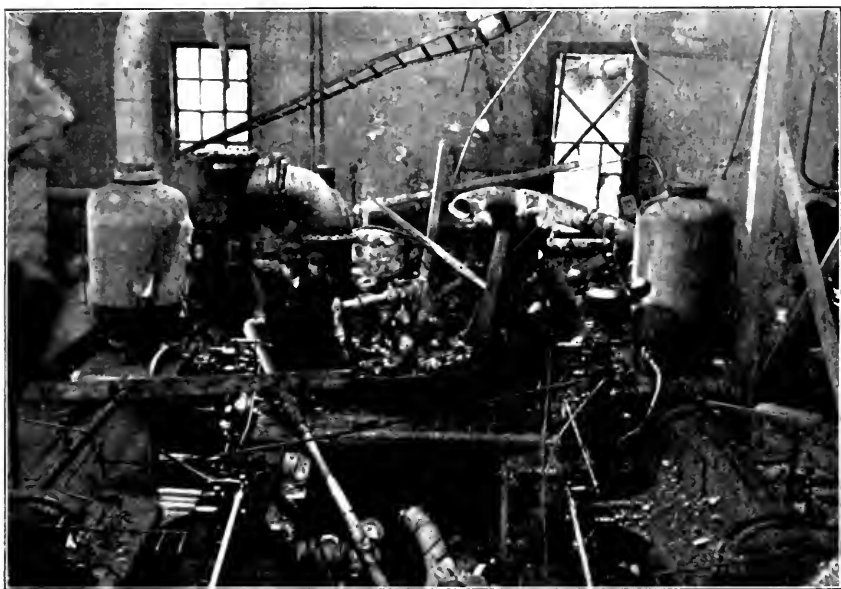
The wheel was of the flange joint type, made in four sections and really consisted of two wheels bolted together which formed a total rim face of 5 feet. The engine on which the exploded wheel was mounted was of the twin type with releasing type of valve gears, both cylinders receiving steam at approximately boiler pressure. One fly-ball governor regulated the cut-off for both cylinders with the usual arrangement of a rockershaft extending from one side of the engine to the other and this feature appears to have had a more or less prominent part in the cause of the engine running away.

The leading cause of the accident was a sudden release of all load from the engine by the breaking of the main driving belt which is thought to have been brought about by a piece of wood wedging between the belt and the face of the wheel. The broken main belt knocked off the governor-driving belt from its pulley so that the governor stopped revolving. If the trouble had terminated there the dire results shown in the illustrations should have been averted by the so-called safety cams on the valve gear which come into play when the governor drops to its lowest position and prevent the further admission of steam to the cylinders. However, as the big belt coiled up into the wheel pit, it broke the afore-mentioned governor rockershaft, which

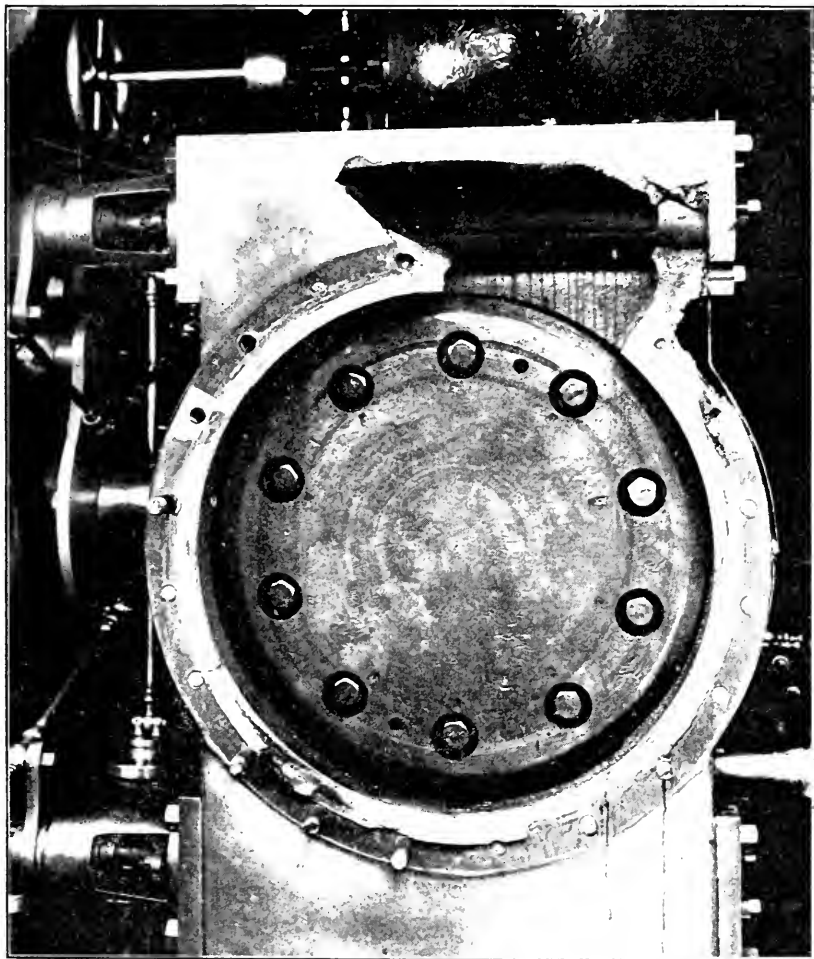
A Mysterious Engine Accident.

ON the front cover and on the following page of this issue we are presenting two views of an accident which occurred not long ago to the steam cylinder of an Ammonia Compressor. Fortunately no one was injured.

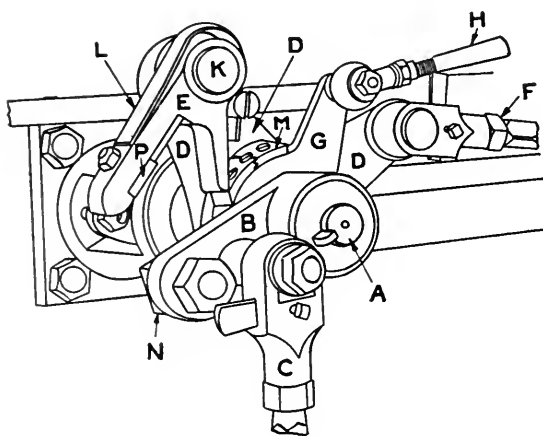
FIG. 1.

Both of these engines were of the Corliss type and overspeeding resulted from breakage of parts of the valve gear. To clearly describe the causes of the accidents reference will be had to some sketches of the typical Corliss valve gear. Fig. 1 shows the

parts of this gear that are intimately related to and operate the steam admission valve for the head end of the cylinder. A similar arrangement is used at the crank end of the cylinder. In this sketch A is the end of the valve-stem, which passes through the other parts of the gear and into the cylinder where it is attached to the cylindrical Corliss valve. The valve is actuated by the oscillation of this valve-stem. Part B is the steam-arm and, as will be seen, is secured to the valve-stem by a key. The rod C, attached to the steam-arm, is drawn down to the position shown in the sketch by a dash-pot on its lower end which is not illustrated here. In the position shown, the steam-valve is closed. The double-arm D is machined to a running fit on the valve-stem and has two arms — one extending to the left and carrying the steam-hook E and the other extending to the right and having attached to it the steam-valve-rod F. This steam-valve-rod is attached, through a series of levers, to the eccentric of the engine and is given a reciprocating motion which changes to an oscillating

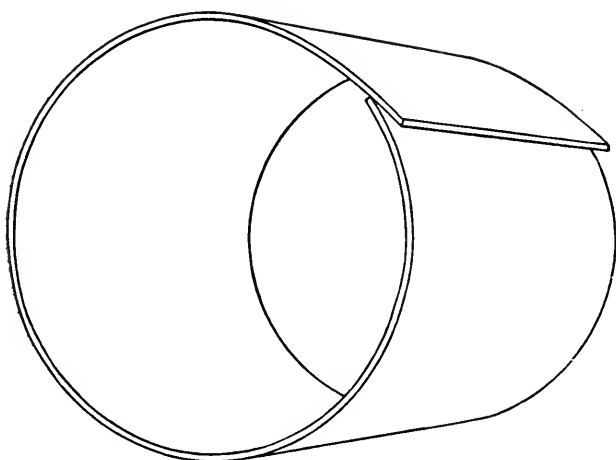
FIG. 1.

When a boiler plate is rolled to a cylindrical form, the edges of the plate, in passing through the rolls, are not gripped as effectively as is the middle of the plate so that the ends are left somewhat flat. The condition produced is illustrated in Fig. 1. This necessitates the plates being forced together at the edges and this produces an added stress that persists unless relieved

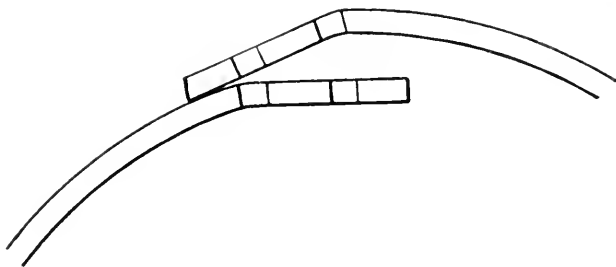
FIG. 2.

by annealing. In addition to this the plates, if bent after punching, will bend along a line of rivet holes as shown in Fig 2 in somewhat exaggerated form.

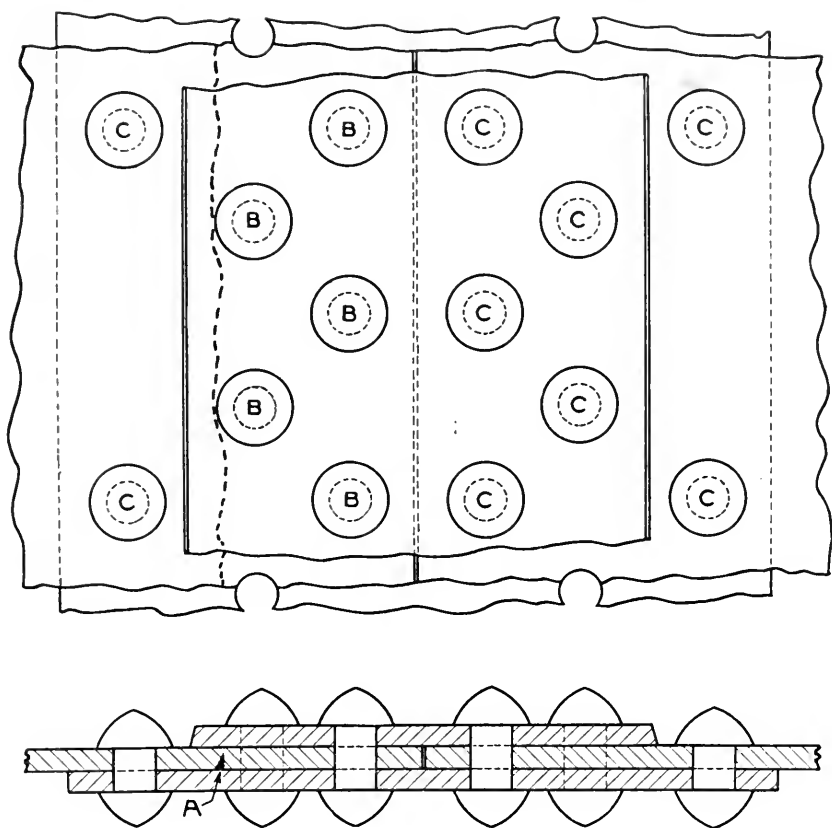
FIG. 5.

Assuming that a double riveted lap joint has been changed to a triple riveted butt construction, the joint, after placing the butt straps and riveting, would appear as shown in Fig. 5 on page 145 with the rivet holes of the original lap joint at B and the new holes at C. If a defect existed in the plate as shown at A the joint would be very faulty. Assuming the original joint as having the rivet holes spaced $3\frac{1}{4}$ inches and the additional holes spaced $6\frac{1}{2}$ inches, if the plate material were defective or contained a lap crack as shown, the failure of the joint would require only the shearing of the rivets in long pitch, or $6\frac{1}{2}$ inches, and the failure of the defective plate.

It might be argued that the exposure of the inside of the lap seam, when the change to a butt seam is made, would reveal the presence of a lap seam crack. A crack of this nature is, however, often present in a boiler of this construction after years of service although it may not be visible to the naked eye. But, even though no crack exists,

it must be remembered that boiler plate, like any other material, becomes fatigued after long years of service and for this reason, after it has been under stress for many years, it should not be subjected to a change of shape and torture of the material in an endeavor to keep the boiler in service, especially when there is evidence that the altered structure is defective.

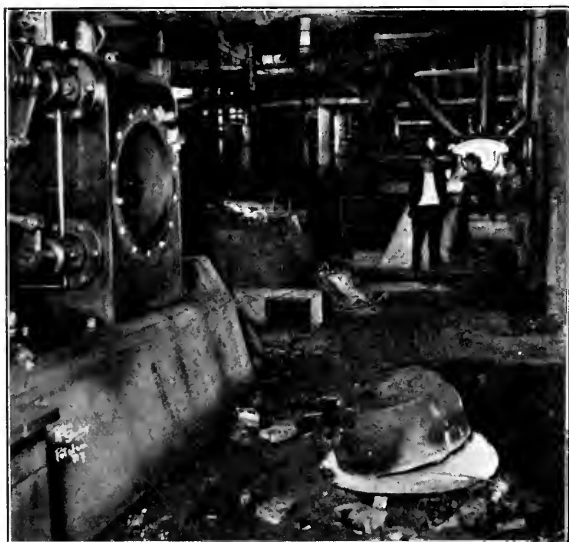
A Recent Engine Breakdown.

THE CYLINDER HEAD END OF THE WRECK.

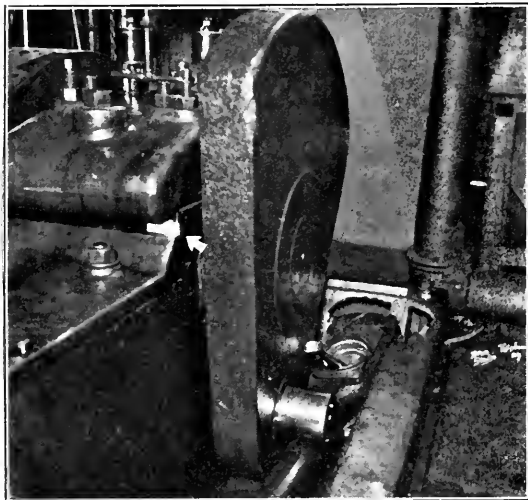
ing-rod, driven by the crank and being somewhat free at the cross-head end, whipped about until it broke the crank-pin brasses and then fell into the crank pit. In this position it did not leave sufficient room for the crank-pin to pass by, with the result that the crank-shaft was

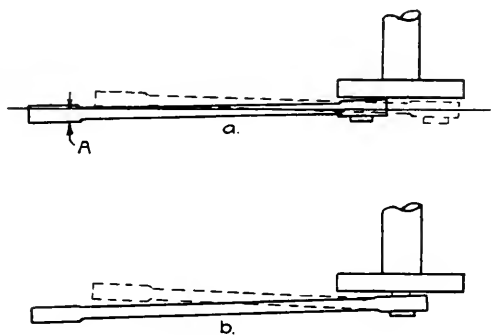
FIG. 11.

The condition produced by a crankpin that has been bent out of parallelism with the crank shaft is illustrated, in exaggerated form, in Fig. 11a. Such a condition will produce overheating and serious strains in the engine when it is running. The trueness of the crankpin in this respect may readily be observed by

turning the crankpin with the rod to one of the positions shown, measuring the distance A, and then swinging the parts to the other position and repeating the measurement. If the two distances, A, agree, the crankpin is in correct alignment but if they do not agree some adjustments must be made either by scraping or by suitable machine work. Conditions vary so greatly that no exact procedure for correcting this type of fault can be prescribed. Since the crankpin may be bent in the direction shown in Fig. 11b the test should also be carried out in the positions shown there.

Another condition that may exist is that the center line of the crankpin brass may not be perpendicular to the center line of the connecting rod. To test for this, connect the rod to the crankpin, bring the bearing brass snugly against the inner shoulder of the crankpin, and note the distance A as in Fig. 11a. Then disconnect the rod from the pin, turn it over half way and repeat the measurement. If the relation between the cylinder center line and the line on the rod is the same as in the first case the crankpin brass is in correct alignment.

face of the crank disc. If in either case the bearings are found out of alignment, they should be scraped or machined to bring them to the correct condition.

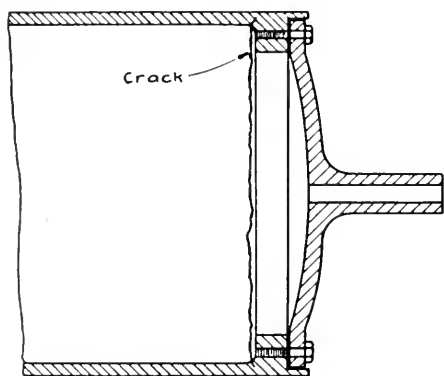
FIG. 1.

It was said that a few days prior to the explosion steam was seen escaping through a crack in the cast iron shell close to one of the heads of the mangle. To stop this leak, autogenous welding was resorted to and while this method of repair temporarily stopped

the escape of steam it would appear that it materially weakened the shell. Examination of the broken parts showed that the casting had been cracked for some time at the base of the flange, as shown in Fig. 1, this defect extending around the circumference meeting the

welded portion at both ends, and varying in depth from one eighth to three eighths of an inch from the inside surface of the shell. The extent of this crack at the point where the leak developed could not be determined because the welding had destroyed all traces other than those mentioned above. The welded portion extended for about twenty-five inches around the circumference and was about five inches wide but its

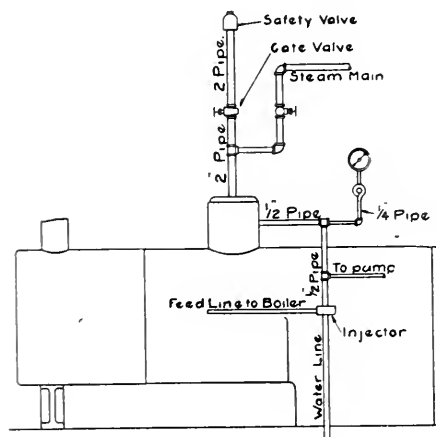
FIG. 2.

"I stepped outside to look up at the valve which was about twelve feet above the boiler and while looking at it the blowing stopped. A few minutes later I walked in and looked at the pressure gauge. It showed 140 pounds. I immediately started an investigation to determine the reason for the safety valve remaining closed with this pressure behind it and, when I climbed up on the boiler, I soon discovered the cause. There I found a gate valve, closed tight, in the line leading to the safety valve. Apparently the engineer had closed

it when I stepped outside for just then I saw him come around to the front of the boiler, glance at the pressure gauge, and then rush up the ladder to open the gate valve. This I cautioned him to do slowly as a sudden release of the pressure on the boiler might have caused an explosion. As soon as a few turns had been given the gate valve to open it the safety valve began to blow and continued to do so until the pressure was reduced to 100 pounds.

"A sketch of the boiler with its improper pipe connections is given in Fig. 2. In addition to what is shown there I might mention that the blow off line had been piped outside the building where a trap had been formed so that any water accumulating in it would freeze very readily. A man, in blowing down the boiler, would have been placed in a very dangerous position.

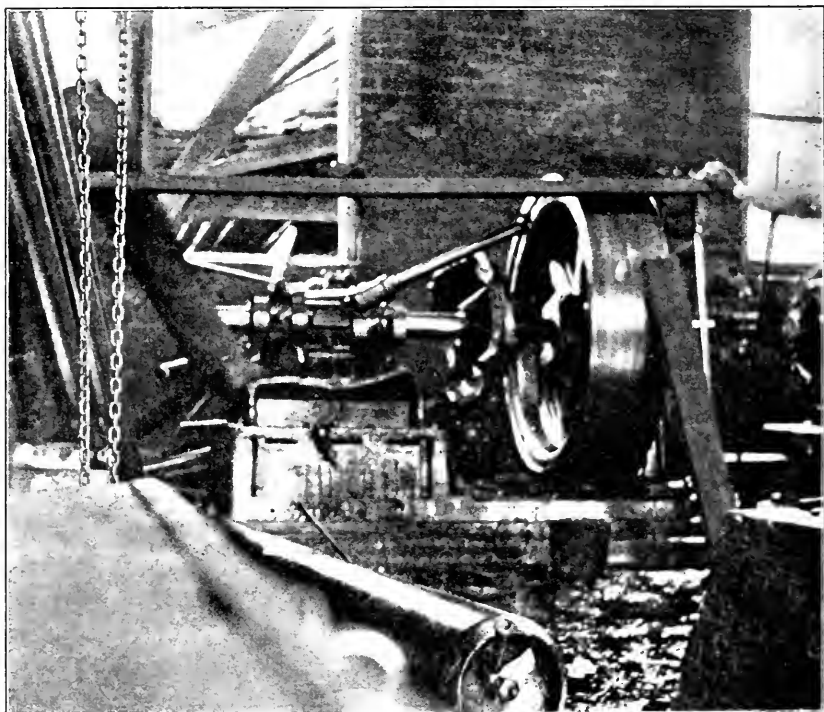
WRECKED AMMONIA COMPRESSOR.

AN accident which is of considerable interest and which should serve as a warning to many owners and engineers of ice and cold storage plants using ammonia compressors is one that occurred a short time ago in one of the southern states.

The machine which figured in the accident was a two cylinder single acting compressor, belt driven from a motor. It had been running with apparent ease and smoothness when suddenly the closed crank case was shattered from internal pressure, as illustrated on page 242, the damage being so great that it was necessary to install another complete machine. Fortunately the machine was covered by a Hartford Engine Policy and the owners were promptly indemnified for the property loss they sustained from the accident.

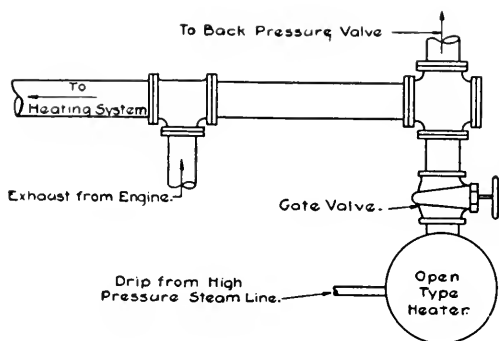
PIPE CONNECTIONS TO HEATER.

WHEN is an "open heater" not an "open heater"? The recent explosion of a feed water heater of this type will serve to show that there is a possibility, through faulty pipe connections, for such equipment to become "closed" and capable of doing severe damage.
